# Manhole Inspection Summary

## Manhole # S11GG1019MH

Insp Date: **2/9/08 11:16 AM**

**Location** Address: **2810 W COLD SPRING LANE** Cross Street: **TOWANDA AVE**

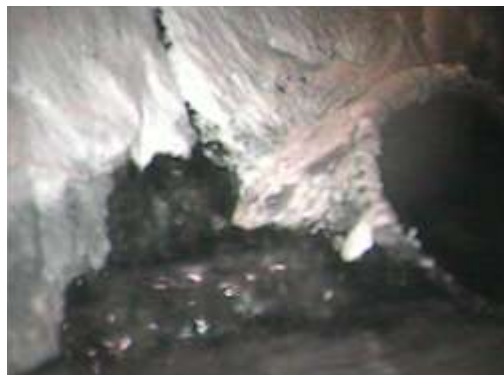
Defect 2

INFILTRATION AT 6 O'CLOCK PIPE

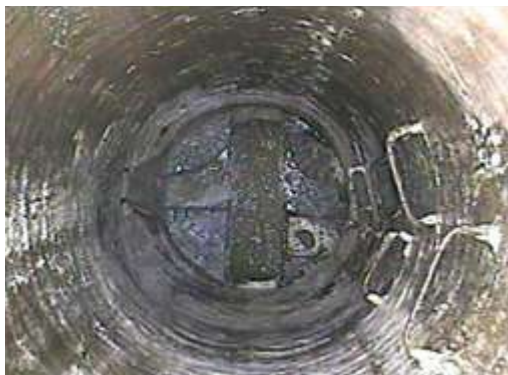
Defect 3

**Steps** Count: **8** Missing: **1** ☒ **Corroded**

CORRODED STEPS

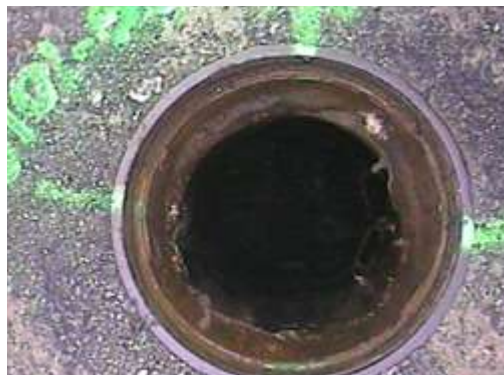
Defect 4

**Frame** Offset: **1** (in.) Condition: ☒ Sound ☐ Cracked ☐ Leaks

FRAME OFFSET

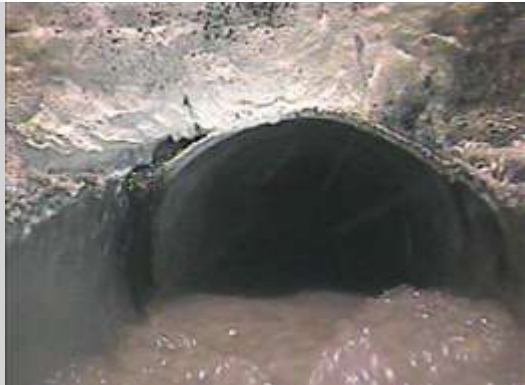
6 O'Clock Inflow

Infiltration: **Evidence** Pipe Seal Cond: **Sound**
